Manhole Inspection Summary

Manhole # S49CC_060MH

Insp Date: **2/18/08 9:54 AM**

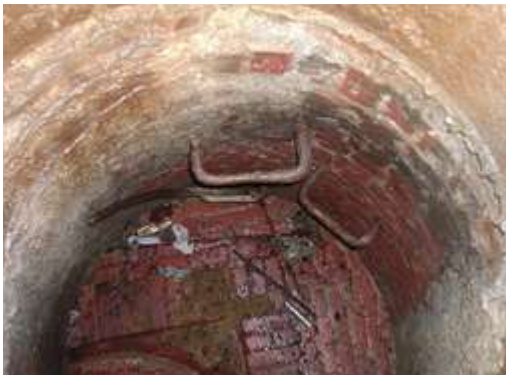
Defect 1

Adjustment Joint

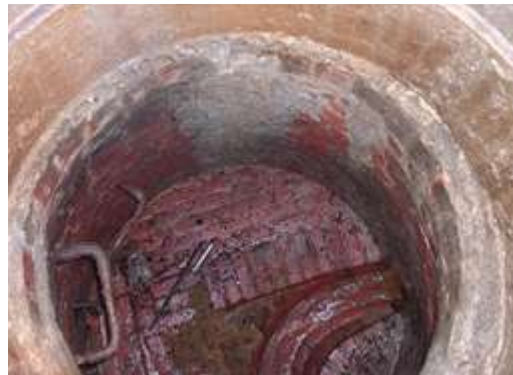
Defect 2

Frame Offset: **2** (in.) Condition: ☐ Sound ☐ Cracked ☒ **Leaks**

Frame Leaks

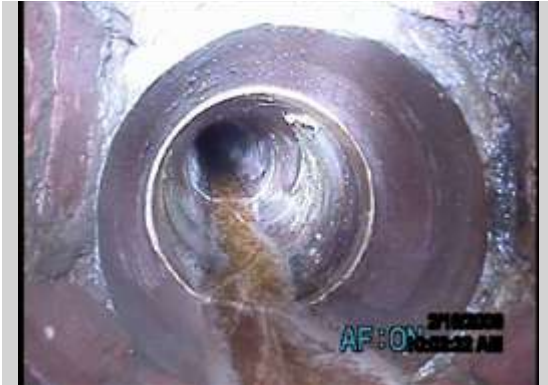
12 O'Clock Outflow

8 in. Circular Gravity Sewer
Pipe Out @ 12 O'Clock

Pipe Height: **8.4** (in.) Rod and Bar (Angled)
Pipe Material: **Clay** ☐ Pipe Lined
Invert Depth: **7.50** (ft.) Flow Characteristics: **Fast**
Deposits: ☒ None ☐ Mud ☐ Sludge ☐ Debris ☐ Grease
Silt Depth: (in.) Deposits Extent:
Infiltration: **None** Pipe Seal Cond: **Sound**

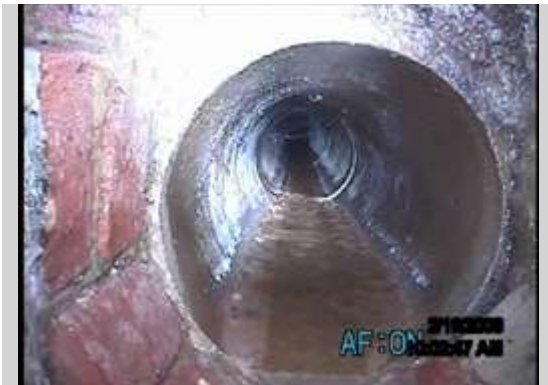
3 O'Clock Inflow

8 in. Circular Gravity Sewer
Pipe In @ 3 O'Clock

Pipe Height: **8.4** (in.) Rod and Bar (Angled)
Pipe Material: **Clay** ☐ Pipe Lined
Invert Depth: **7.13** (ft.) Flow Characteristics: **Fast**
Deposits: ☒ None ☐ Mud ☐ Sludge ☐ Debris ☐ Grease
Silt Depth: (in.) Deposits Extent:
Infiltration: **None** Pipe Seal Cond: **Sound**
